Anthropogenic impact on the environment: the case study of Lake Koronia, Greece

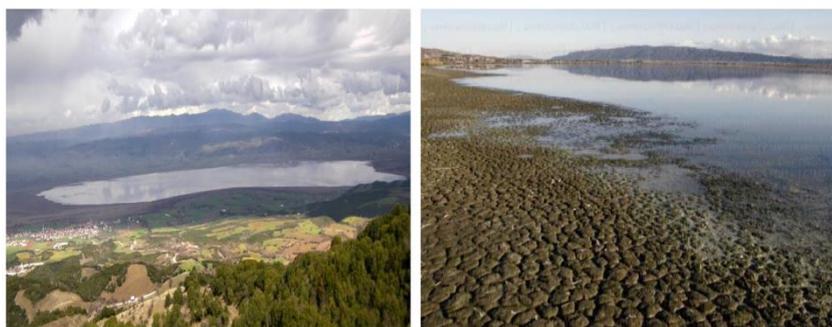
Figure 1: Lake Koronia. The surface of the 4th largest lake in Greece declined progressively in 30 years and its volume and surface area of water was reduced by 80% (Valavanidis Ath., et al, 2015).

- Eutrophication and anoxic conditions on the lake bottom.
- Decrease of fish population and of habitats suitable for birds and amphibians.
- Reduction of the lake surface by ca. 15 km² until October 1995 (Fig. 1).
